Revista Ibero-Americana de Ciências Ambientais

# Multitemporal analysis of the NDVI Distribution in the city of Garanhuns-PE

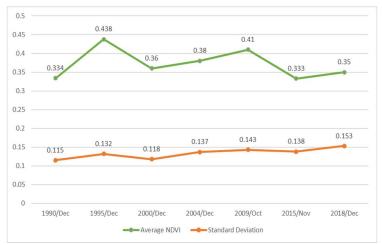
Figure 3: Normalized Difference Vegetation Index (NDVI) of the urban area of Garanhuns-PE and its surroundings. Source: Adapted from Landsat 5 and Landsat 8.

The 3D model (Figure 2) of the urban area of Garanhuns and its surroundings has a superficial area of 65,37 km<sup>2</sup> and the flow vectors that were generated resulted in a total of 25,03 km of length. An area of 60 meters was generated around said flow vectors in the ArcGIS 10.4 software resulting in an area of 3,02 km<sup>2</sup>. Figure 3 is the result of the application of the NDVI equation on the 3D model above, containing average the NDVI values and standard deviation.

The average NDVI of the urban perimeter and its surroundings do not show a downward trend, which would be expected for a region under a constant expansion of its urban area. However, there is a clear upward trend in the standard deviation of the NDVI, which increased by 33,04% between 1990 and 2018. According to Deus et al. (2015) the urban area of Garanhuns increased by 20,4% from 1990 to the year 2000 and 27,8% from 2000 to 2010. To Soares et al. (2018) the urban growth in Garanhuns was aggravated in the 2000s due to an expressive expansion of the local universities and the increase of the service sector. Melo et al. (2013) point out that the intense urbanization process was responsible for the removal of most of the region's vegetation cover, leaving only remnants in some areas of the municipality of Garanhuns.

The increase of the standard deviation reveals changes in the distribution of the NDVI values in the region, since according to Triola (2019) this statistical parameter is an indication of how much of the data is deviating from the mean value, where the greater the standard deviation is, the higher the data's variability. Thus, these changes can indicate that the average NDVI is constant, but the distribution is not, revealing an increase in both the number of areas with dense vegetation and those with bare or occupied soil.

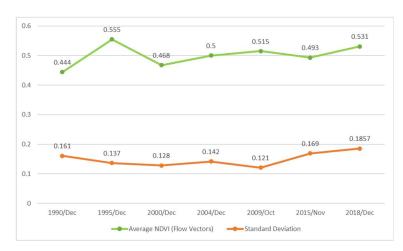
**Figure 4**: Normalized Difference Vegetation Index (NDVI) of the 60 meters area surrounding the flow vectors of the urban area of Garanhuns-PE and its surroundings. **Source**: Adapted from Landsat 5 and Landsat 8 and NASA 2011.

Figure 4 is the result of the application of the NDVI equation on the 60 meters area surrounding the flow vectors from the watershed map of the study region, containing average values and the standard

Results obtained in the 60 meters area surrounding the flow vectors of the watershed map, showed a higher NDVI average than the region's NDVI average as a whole. This discrepancy is attributed to the greater availability of runoff in these areas. It can be observed that the NDVI average has an upwards trend where it increased by 19.59% in the period 1990 to year 2018. The standard deviation showed a downward trend in the period of 1990 to year 2009 and an increase of 52.89% from 2009 to year 2018. This increase coincides with the construction of several large, gated communities surrounding the urban area which initiated an aggressive process of soil sealing in order make these constructions feasible.

The data suggests that the urban development model applied in Garanhuns created imbalances on the natural landscape. The growth of the average NDVI in areas near water streams indicates that there was an improvement in the conditions necessary to allow reproduction of the vegetation cover. However, the standard deviation narrates a scenario where there is an increase in the dispersion of the vegetation, indicating that although the growth of the urban area is creating regions of exposed or occupied soil, it is also creating a scenario of prosperity in regions of natural water flow.
